**Client:** 108 Downie Street, Stratford, Ontario

**Topic:** Remove multiple layers of paint from historical building

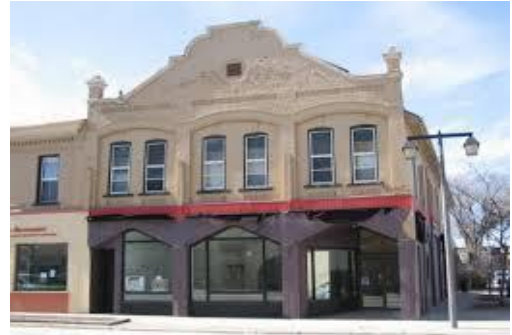
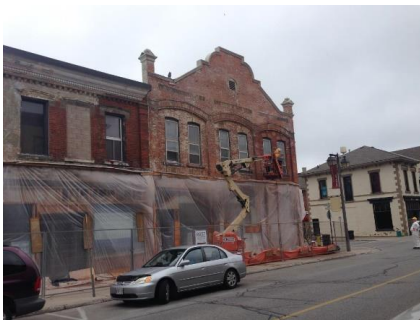
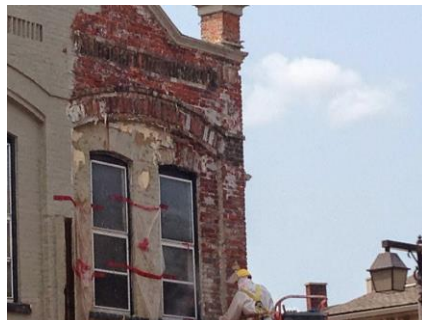
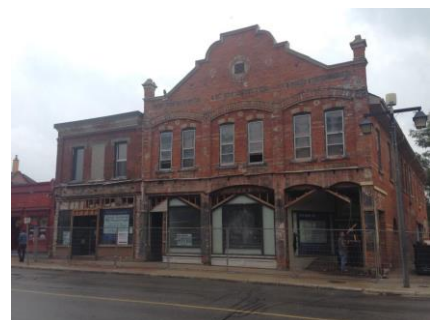
- ∴ One of the multiple layers of paint was found to contain lead so collection of all run off and paint removed was required.
- ∴ Pedestrian traffic on public sidewalk surrounding the building.
- ∴ Clay brick, so harder media would result in profiling (pitting) and softer media would result in worming (paint is non-uniformly removed, causing tunneling through the brick).
- ∴ The front of the building is east facing so the sun would dry out stripping chemicals quickly if applied in the morning hours.
- ∴ Multiple applications of chemical stripping required to remove many layers of paint.

- ∴ Use of an articulating lift which allowed the erection of fencing and plastic on the sidewalks to contain the run off and debris from paint removal and to prevent pedestrian traffic in the hazardous area.
- ∴ Use of chemical stripping with hot water pressure washer at approximately 2,500 psi removed the paint with minimal issues.
- ∴ Applying chemicals to the front of the building during the afternoon and using hot pressure wash the following morning to remove chemical and paint.
- ∴ Up to three applications of chemical stripping to remove all paint layers was necessary.

- ∴ Restoration of the original look of the building.
