**Bathurst – Waterproofing Foundation Wall
Before – Evidence of water infiltration**

Bathurst – Waterproofing Foundation Wall

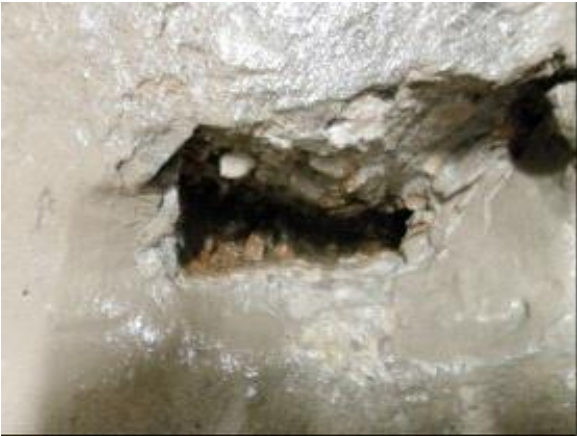
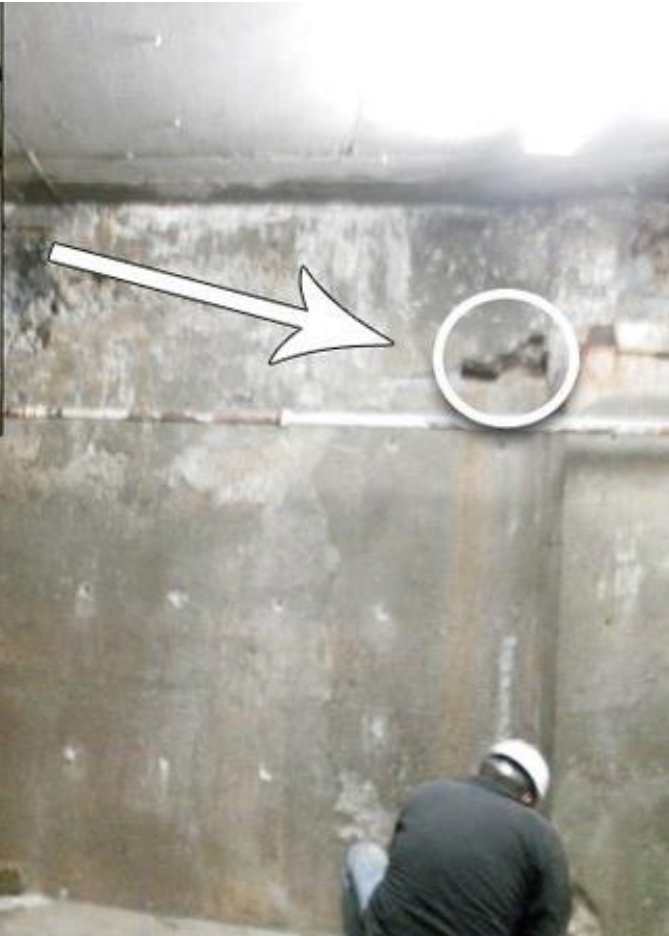
**Bathurst – Waterproofing Foundation Wall
Found active leak**

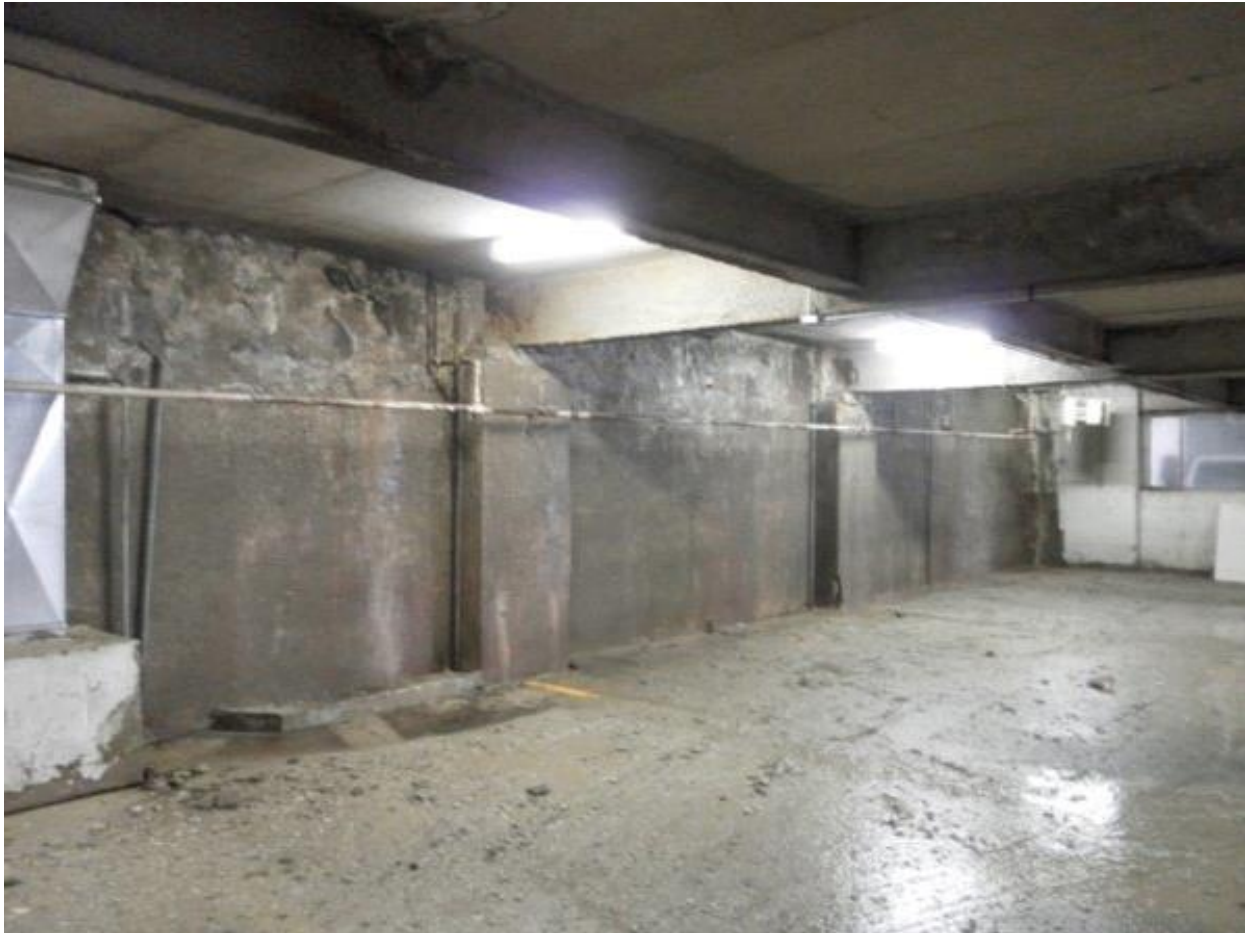
Bathurst – Waterproofing Foundation Wall
Surface ready for application
