CN2000® TEST PROJECT ON BRIDGE PYLONS EXPOSED TO THE TIDAL EFFECTS OF SEA-WATER

July 2008 Updated

US TEST PROJECT CONDUCTED BY KELSO COATINGS ON BRIDGE PILES EXPOSED TO TIDAL EFFECTS OF SEA-WATER

Piles - Supporting a Bridge, Spanning a Tidal Channel in the Southern U.S.

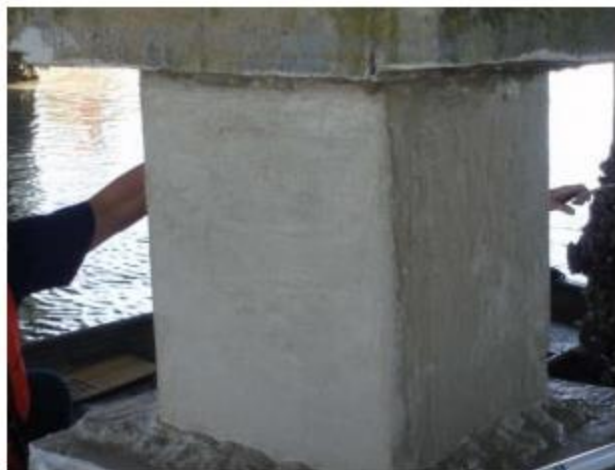
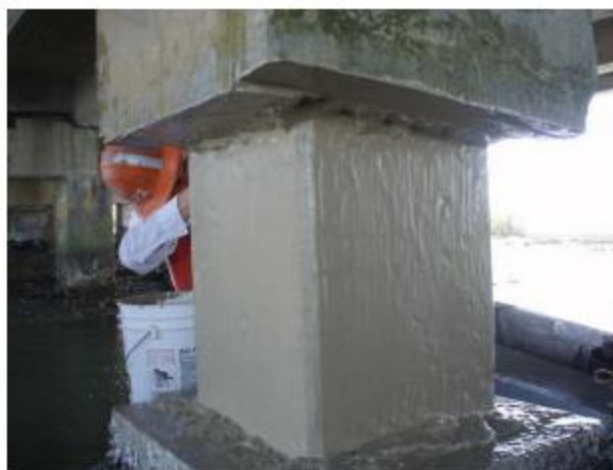
After removing the concrete shield, 2 coats of **CN2000®B** is applied by brush to the exposed pylon to a thickness of +1mm and allowed to set for 1 hour between coats

Once the final **CN2000®B** coating has set, a flexible coating of **CN2000® C+D** is applied to ensure proper hydration of the **CN2000®B** and to prevent contamination of the coating by seawater and to allow the proper 24 hour curing of the **CN2000®B** coatings.

NOTE: The application of the **CN2000® C+D** in this project was utilized as a physical barrier and waterproof membrane to protect the **CN2000®B** coating during its 24 hour curing phase in the same way one would use a plastic film, due to the rising tide and splashing of the salt water. Normally on a static structure such as piles, the proper application and curing of **CN2000®B** would be sufficient to ensure a permanent waterproof membrane on the pile.

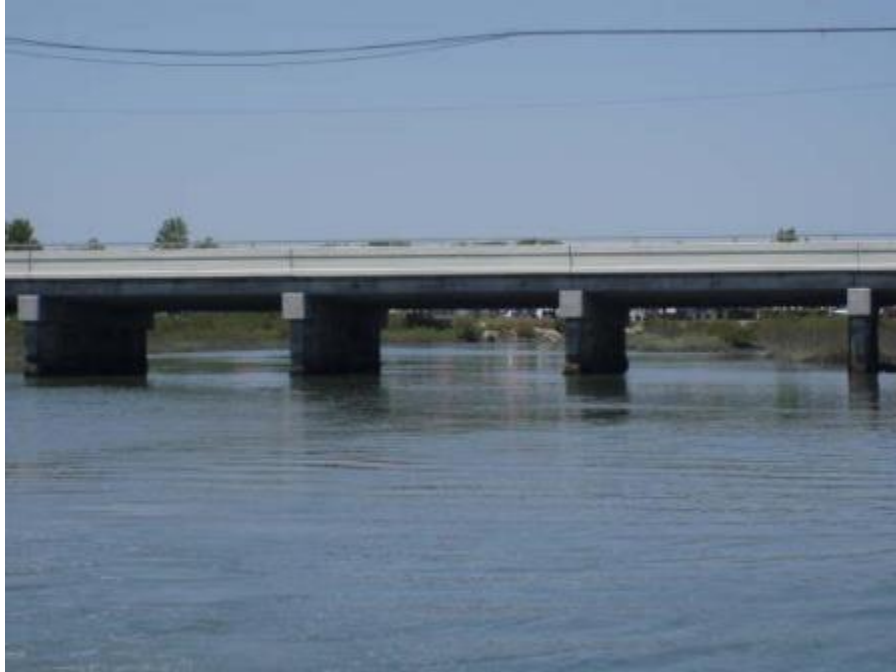
Each Pile that supports the bridge is an independent reinforced concrete column 18 inches by 18 inches and is entirely shielded by a 6 inch concrete shielding jacket.

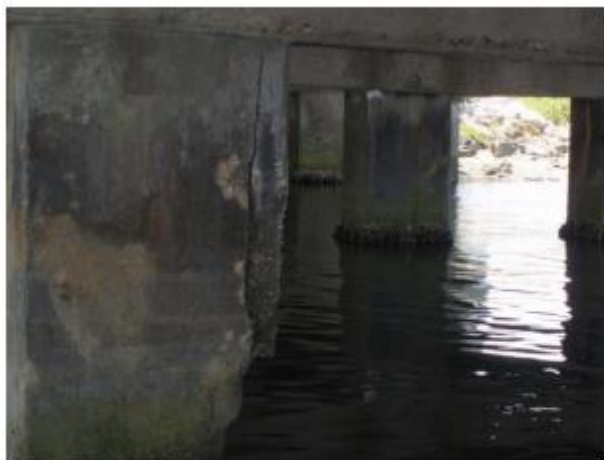
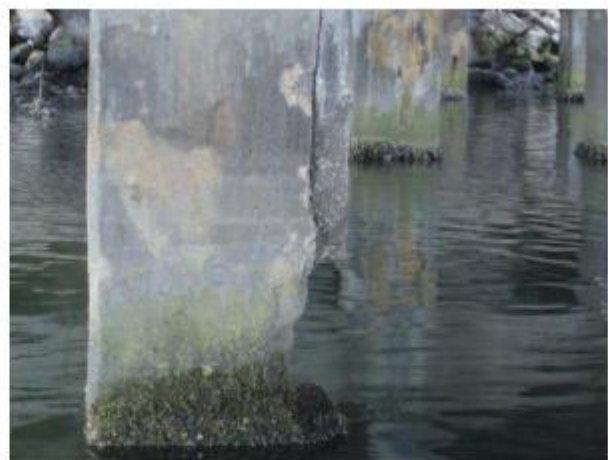
The above 2 photo's show the extensive damage to the concrete shielding jackets, which now allows the corrosive environmental effects and the tidal actions to attack the unprotected reinforced concrete structure of the pylon.

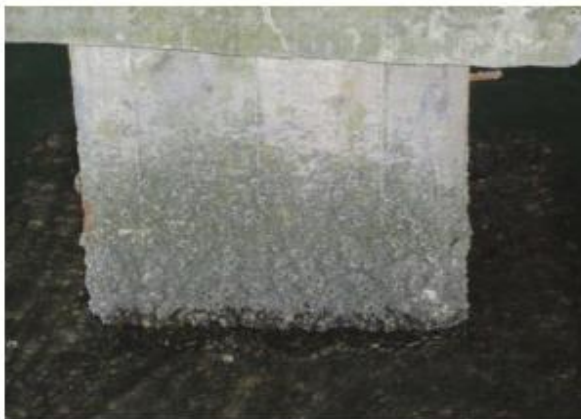
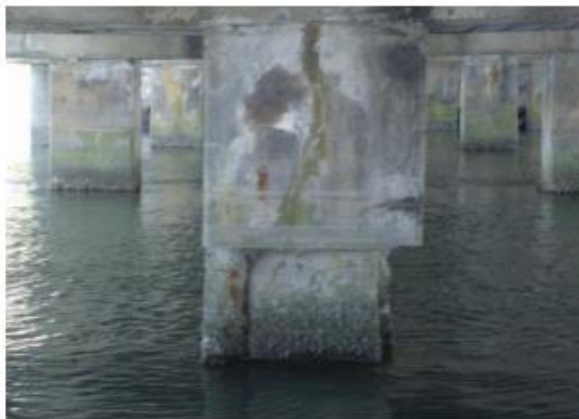
The above 2 photo's show the exposed reinforced concrete piles (fully exposed pile on the left, and the partially exposed pile on the right).

After only 3 weeks of exposure to the environmental effects, one can note the extensive growth of barnacles and other sea life, and the saturation of the sea water/air interface zone of the concrete pile with salt water, resulting in the chlorides affecting the steel reinforcing bars within the concrete structure causing damaging corrosion of the steel reinforcing bars.

At low tide, when the work area was completely exposed, Department of Transportation workers under the guidance of **Kelso Coatings** personnel and under the watchful eye of State Environment Conservation Personnel thoroughly cleaned the exposed piles down to the substrate.

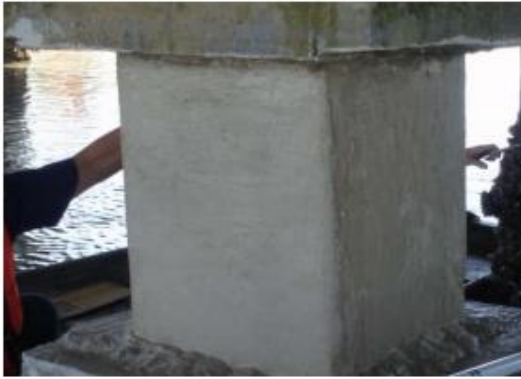
After removing the concrete shield, 2 coats of **CN2000®B** is applied by brush to the exposed pile to a thickness of +1mm and allowed to set for 1 hour between coats.

After cleaning, the exposed substrate was saturated with fresh water and the first coat of **CN2000®B** was applied by brush coating in the proscribed manner to a thickness of +0.5mm to all the exposed surfaces of the pile and the exposed surfaces of the concrete shielding jacket. After 1 hour, when the **CN2000®B** had set (not sticky to the touch) a second coat (+0.5mm) was applied to bring the coating to the proscribed thickness of +1mm

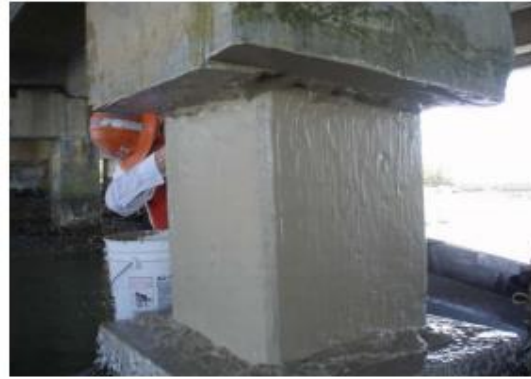
Once the final **CN2000®B** coating has set, a flexible coating of **CN2000® C+ D** is applied to ensure proper hydration of the **CN2000®B** and to prevent contamination of the coating by seawater and to allow the 24 hour curing of the **CN2000®B** coatings.

After the second coat of **CN2000®B** had set, (1 hour) D.O.T. workers applied a flexible **CN2000®C+D** coating by brush over the areas previously coated with **CN2000®B** to ensure a complete waterproof membrane of the pile to protect the **CN2000®B** coating from the environment to allow proper curing.

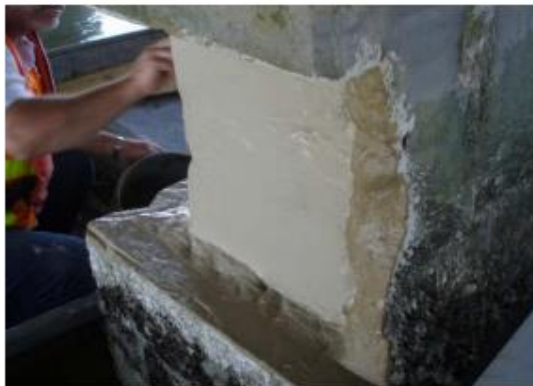
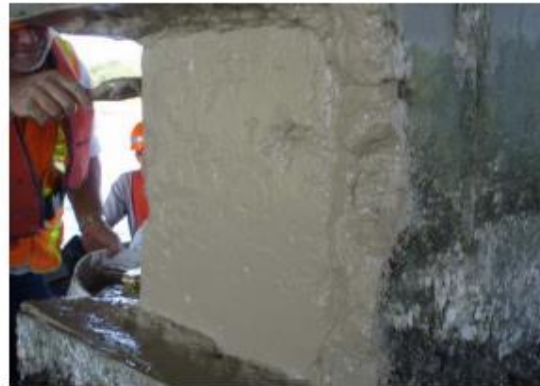
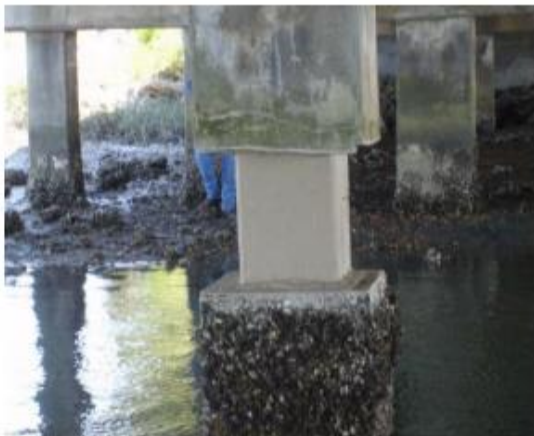
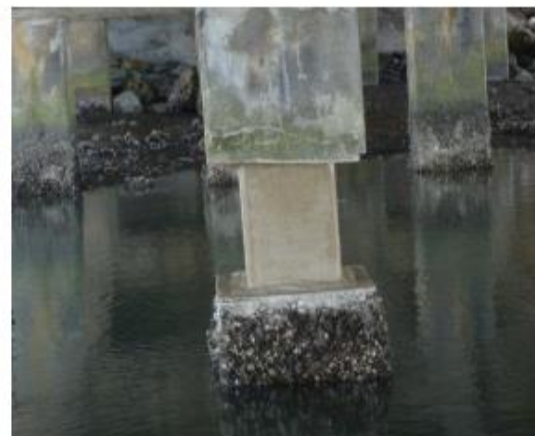
Piles successfully waterproofed with the **CN2000®** line of waterproof products will cure in only 24 hours

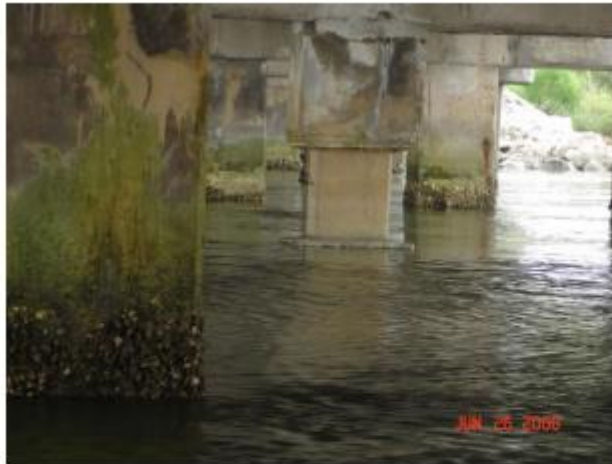
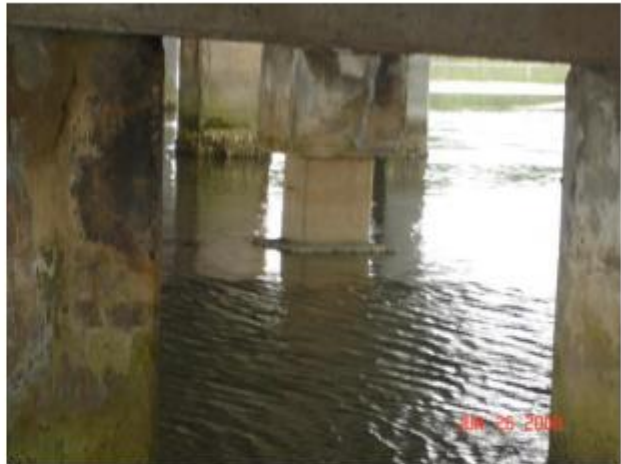
After 3 months exposed to the corrosive environmental effects and the tidal actions, the test piles appear almost the same, as the day the CN2000® coatings were applied

- ✚ Although the CN2000®C+D coating only cured 1½ hour prior to being submerged by the rising tide, our observations indicate that the bonding to the substrate is still consistent.
- ✚ The CN2000® coatings have maintained their integrity and continue to protect the piles.
- ✚ There is no apparent erosion damage to the coated piles.
- ✚ Barnacles and other sea life are not adhering to the CN2000®C+D coating.

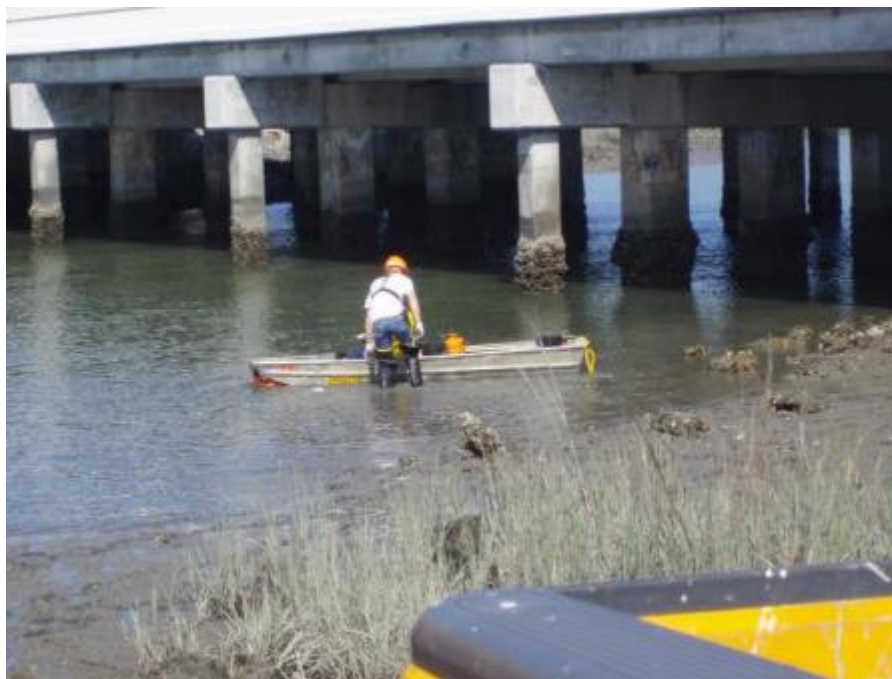
The simple and convenient application of **CN2000® Cementitious Capillary Crystalline Waterproofing (CCCW) Series of Waterproof Materials** has resulted in a permanent waterproof membrane to the test pile, effectively replacing a vast quantity of concrete that previously, had to be intermittently removed and replaced and never really provided a waterproof membrane, but only a thick, porous physical barrier between the corrosive environment and the steel structure within the concrete of the pile.
