## Water Infiltration causing Mould & Mildew CN2000 to coat the interior concrete

By Ron Langdana, President, Kelso Coatings

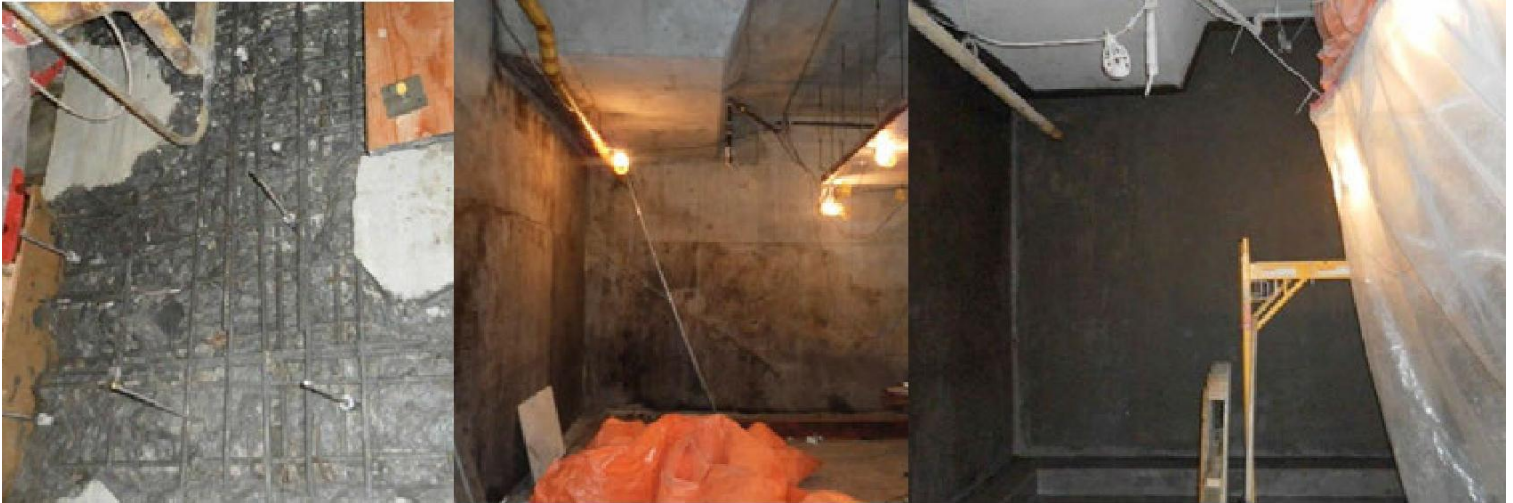
Active leak coming in the basement level of the foundation walls of the produce cooler room causing a significant problem for employees and food storage for a major retail supermarket chain.

- Two days to prepare the concrete.
  - Chase the cracks and sandblast the concrete to open the pores.
  - During the prep phase, our team found structural concerns in the concrete. Kelso worked with the consulting engineers to complete the repairs.

- One day to apply.
  - Active leaks were terminated using the CN2000® A (Insta-plug) material.
  - Once the new concrete was installed and cured, the CN2000® B/C/D system was applied to the entire area.
  - 24 hour cure period once CN2000® C&D was applied and ready for paint.
