Client: Fire and Emergency Services Training Institute, Toronto, Ontario

Topic: Water leaking through foundation walls into the elevator pit

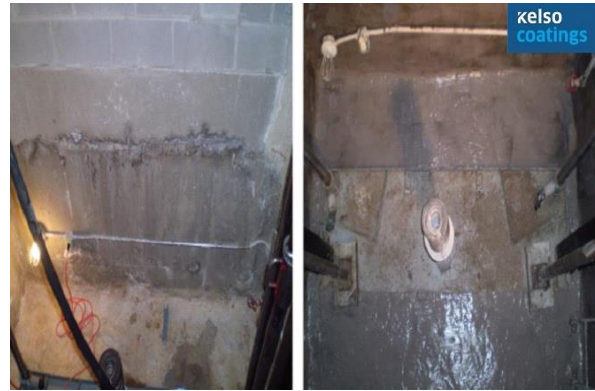
- ∴ Fire and Emergency Services Training Institute which attracts firefighters from around the globe as a centre of training excellence for fire and emergency services was experiencing leaking through the foundation walls into the elevator pit, especially during heavy rain or after the winter season.

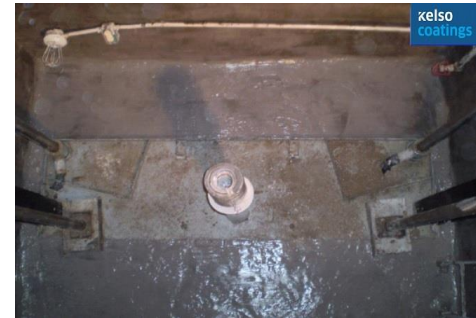
- ∴ Cold joint showed visible signs of water infiltration.
- ∴ Many flanges, mechanical hydraulics and rails secured to the concrete slab of the elevator pit.
