Client: Toronto Pearson Airport, Toronto, Ontario

Topic: Ground water leakage into glycol tank man hole

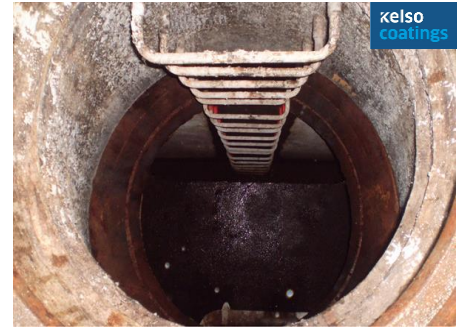
- ∴ The Greater Toronto Airport Authority sells its recycled glycol for windshield washer fluid. The below grade tanks were experiencing significant ground water leakage because of erosion and cracking in the concrete walls.

- ∴ After the surfaces were prepared, CN2000B® waterproofing solution was applied to the voids around the repaired section which molecularly bonded to the concrete and stopped the leaks.
- ∴ Two coats of CN2000B® were applied on the inside of the concrete walls to repair the cracks.
- ∴ All remaining walls were coated with CN2000B® to prevent any further water infiltration.
- ∴ After the application of CN2000B®, a single coat of CN2000C® and CN2000D® were applied to maintain the hydration required for the CN2000B® to cure according to specifications.
