Client: Toronto Pearson Airport, Toronto, Ontario

Topic: Below grade water leak in luggage area

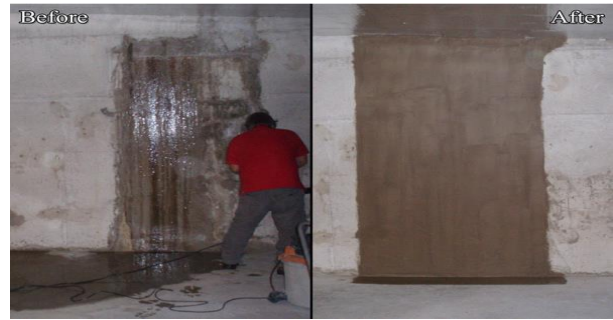
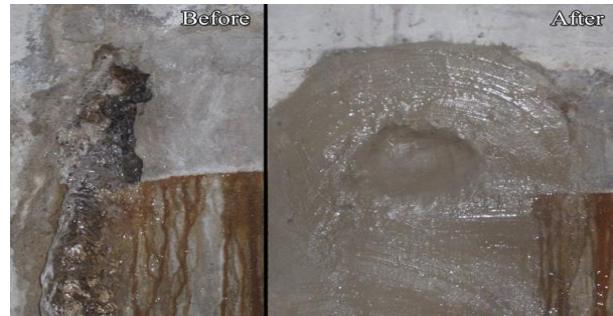
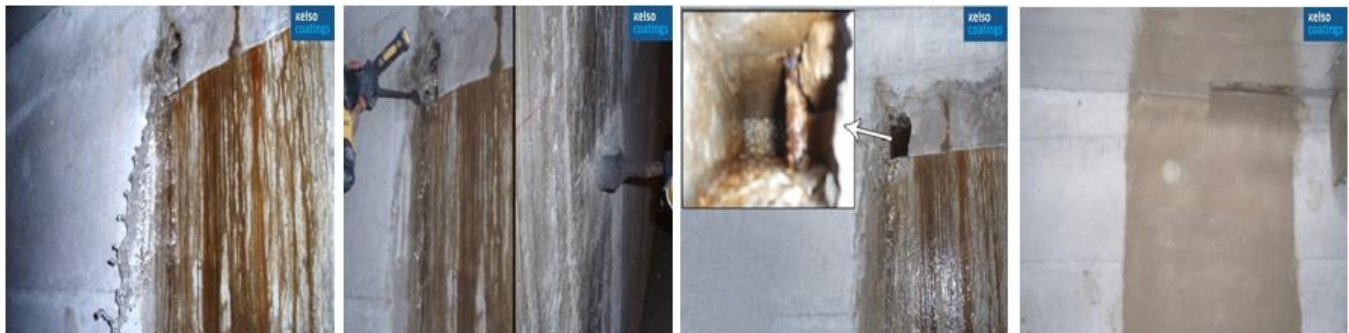
- ∴ The Greater Toronto Airport Authority had a luggage area that was unusable because of a twelve year active leak 20 feet below grade.

- ∴ CN2000A® was required to act as an insta-plug directly in the cavity of the wall, which swelled and consolidated with the existing substrate.
- ∴ After the active flow of water stopped, two coats of CN2000B® were applied to the area of the leak and surrounding area. CN2000B® creates a molecular bond with the concrete and continues to penetrate the structure as long as there is moisture. CN2000B® also contains powerful self-healing compounds to continue to self-repair cracks in the substrate that may form decades after application.
- ∴ To speed up the curing process, CN2000C® and CN2000D® were applied to maintain the hydration required for the CN2000B® to cure according to specifications.
