Client: Jacques Cartier Bridge, Montreal, Quebec

Topic: Hairline cracks in the high performance barrier walls which would ultimately lead to corrosion of the reinforcing steel and require replacement of the bridge structure

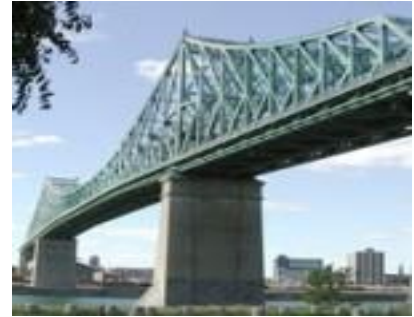
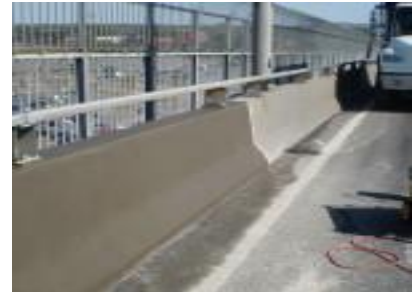
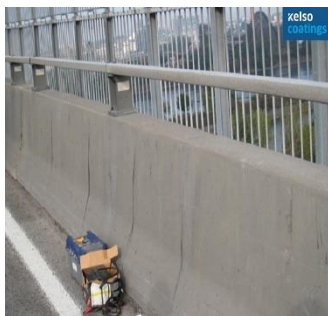
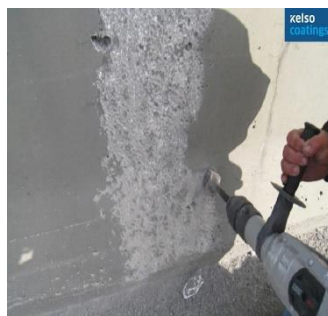
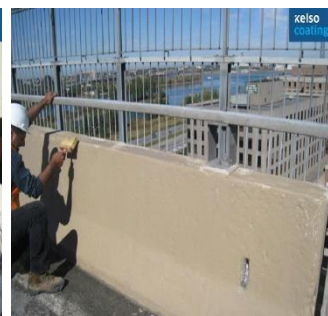
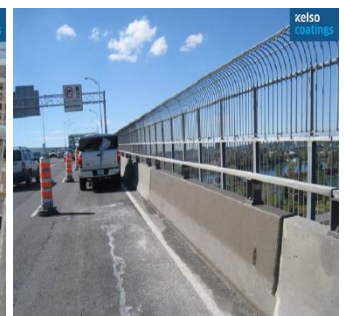
- ∴ Busy highway location.
- ∴ The sidewalk, walls and bridge deck were all constructed as one piece.
- ∴ Cracks would lead to corrosion from chloride ion and freeze/thaw cycles.

- ∴ The surface was prepared for the CN2000® coating.
- ∴ Two coats of CN2000B® were applied to the wall to prevent any further deterioration and provide a self-healing solution for future cracks.
- ∴ After the second coat of CN2000B® set, two coats of the polymer flexible membrane CN2000C® and CN2000D® were applied on top of the CN2000B® coating to provide a labour-free curing process (no mist spraying required), which gives the coating more flexibility to provide protection from vibrations on the bridge deck.
