Client: Midas Auto Service, Toronto, Ontario

Topic: Water leaking through above grade foundation wall in hard rain

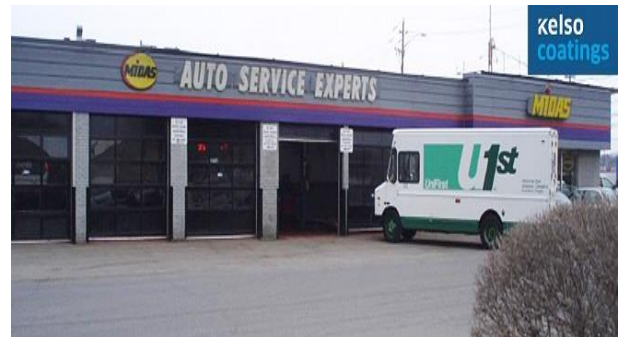
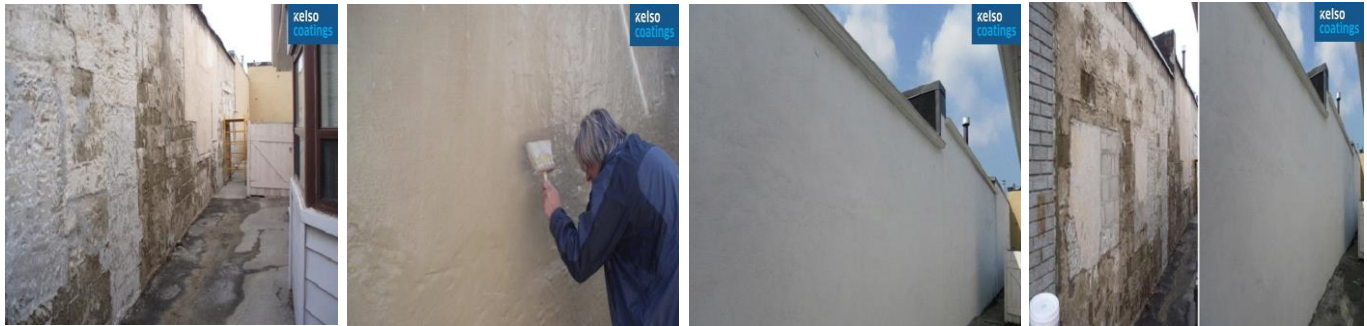
- ∴ A retail location with significant leaking through an above grade foundation wall after a hard rain.

- ∴ Busy retail location.
- ∴ Previous cementitious parging materials were evident on site however they had not stopped the leaks when rain hit the wall. The loose debris and old cementitious coating had to be removed.

- ∴ The surface was prepared for the CN2000® coating.
- ∴ The first coat of CN2000B® was applied with a brush and the second coat was applied with a trowel to give a nice looking surface for the subsequent stucco exterior coating.
- ∴ After the CN2000® solution was applied and verified for no water penetration, the stucco was applied directly to the CN2000® coating.
