Client: Metro Toronto Condo Corporation, Toronto, Ontario

Topic: Water corrosion in elevator pit a concern for public safety

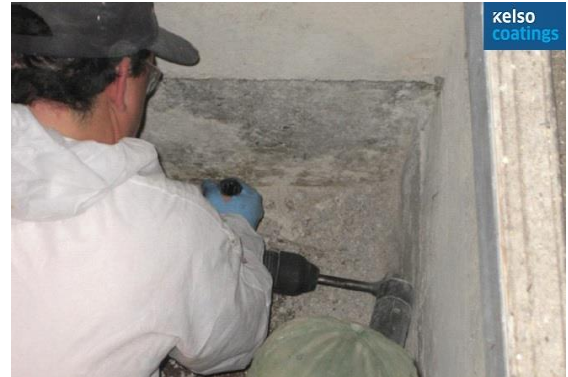
- ∴ The Metro Toronto Condo Corporation (MTCC) and the Technical Standards and Safety Authority (TSSA) were concerned that water in the elevator pit would corrode the components of the elevator car such as the car buffer, guide rails, cables and pulleys, which becomes a safety issue.

- ∴ Cold joint where the concrete slab and walls meet showed visible signs of water infiltration.
- ∴ Many flanges, mechanical hydraulics and rails secured to the concrete slab of the elevator pit.

- ∴ Kelso Coating's certified applicators u-grooved along the cold joint approximately ½" – 1" in depth in order to pack the CN2000B® material into the groove.
- ∴ The surface was prepared by removing the paints, debris and any other contaminants which were visible on the area in need of repair.
- ∴ Two coats of CN2000B® were applied on the exterior walls and floor slab of the elevator pit.
- ∴ After the application of CN2000B®, a single coat of CN2000C® and CN2000D® were applied to maintain the hydration required for the CN2000B® to cure according to specifications.
