**Client:** Toronto Transit Commission Station, Toronto, Ontario

**Topic:** Major ceiling leak in electrical room

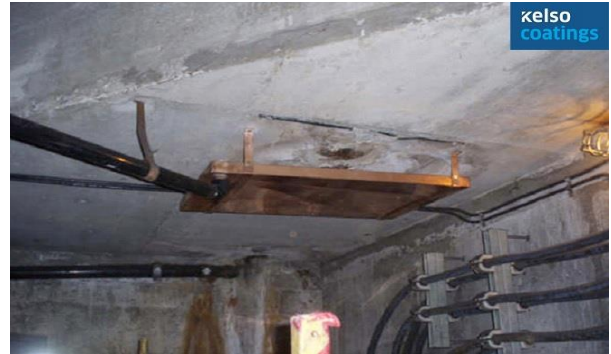
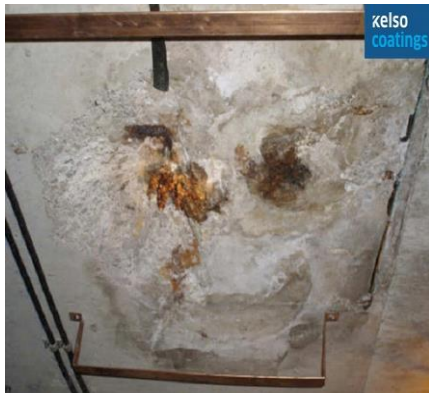
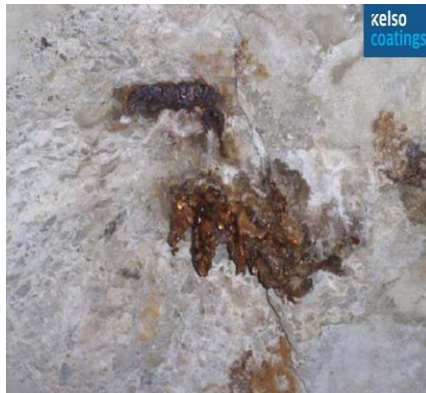
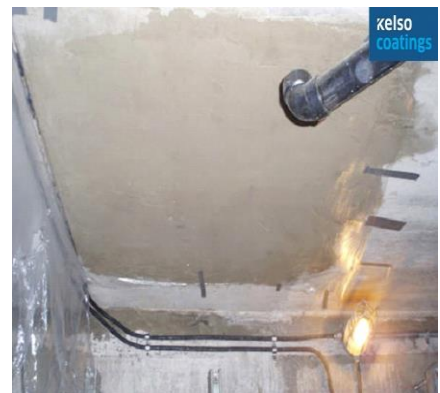
- ∴ The Toronto Transit Commission was struggling with a major ceiling leak in the electrical room at one of the stations.

- ∴ Previous interim solution had been to hang a copper drain pan and pipes, so these required removal.
- ∴ Working within confines of electrical room and electrical equipment.

- ∴ All surfaces in the electrical room had to be cleaned of all contaminants and prepared for the waterproofing solution application.
- ∴ Two coats of CN2000B® were applied on the surfaces within the electrical room.
- ∴ After the application of CN2000B®, a single coat of CN2000C® and CN2000D® were applied to maintain the hydration required for the CN2000B® to cure according to specifications.
