**Client:** Toronto Transit Commission, Toronto, Ontario

**Topic:** Active water leak into elevator pit

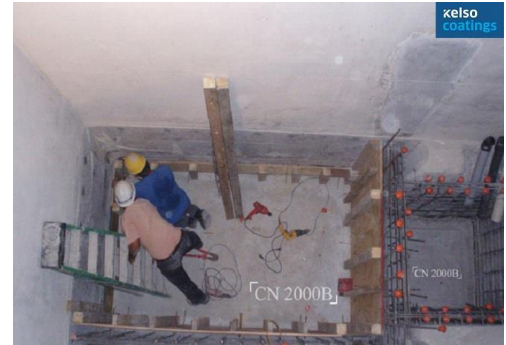
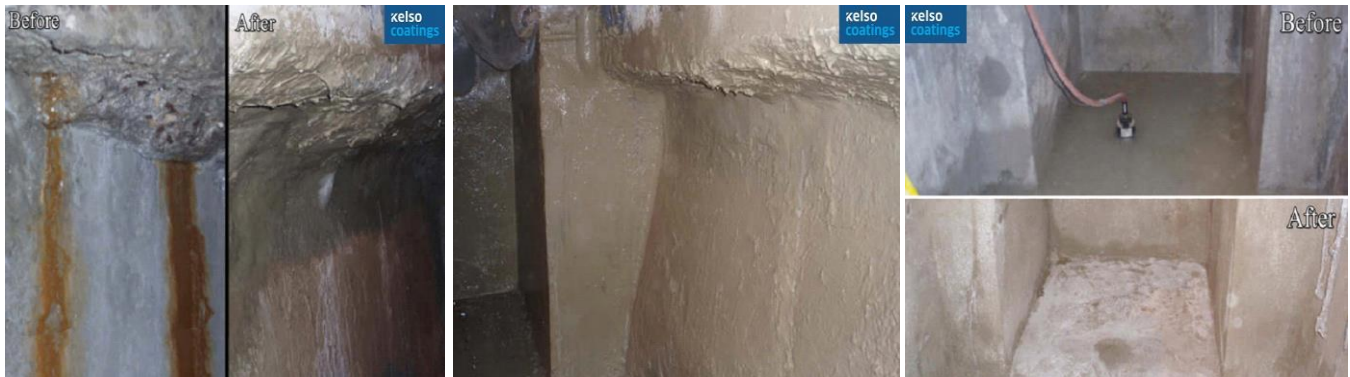
- ∴ Toronto Transit Commission was experiencing a water leak into the newly constructed elevator pit of the North York Station, one of TTC's busiest stops.

- ∴ Active water leak inside the elevator pit.
- ∴ The Toronto Transit Commission requires union workers to complete maintenance and construction work, so Kelso Coatings trained and certified the union crew to prepare the surface and apply the CN2000® products.
- ∴ Kelso Coatings oversaw the application and ensured quality standards.

- ∴ CN2000A® was applied to stop the active water flow.
- ∴ Two coats of CN2000B® were applied on the entire wall and floor area of the elevator pit to provide the bonding and self-healing capabilities through its eka-molecular sieve structure.
- ∴ Once cured, the CN2000B® coating cannot be punctured so new concrete slabs can be poured directly on top of the CN2000B®. No protection board is required.

- ∴ The elevator pit is no longer leaking and Toronto Transit Commission union workers are trained and certified in the application of CN2000® products.
