Ceiling slab waterproofing repair
Initial assessment

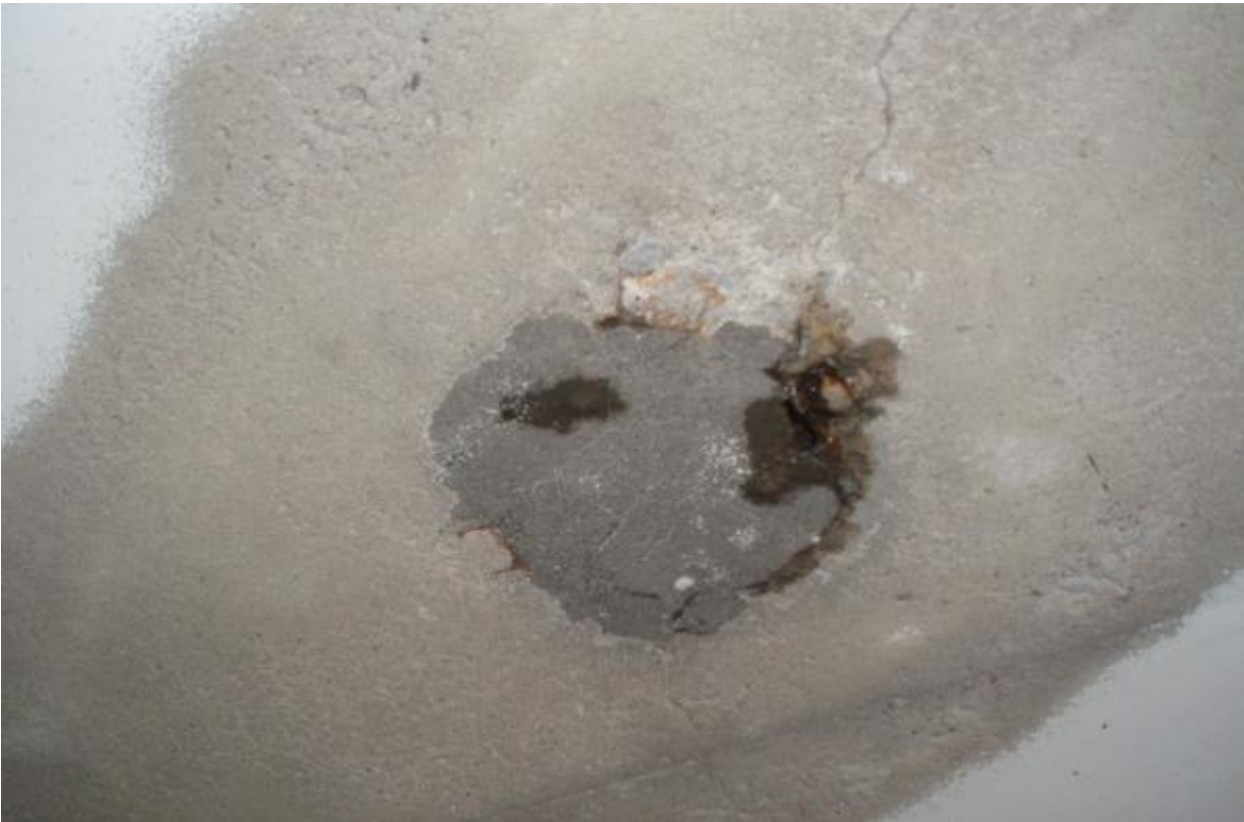
Ceiling slab waterproofing repair
Point of seepage

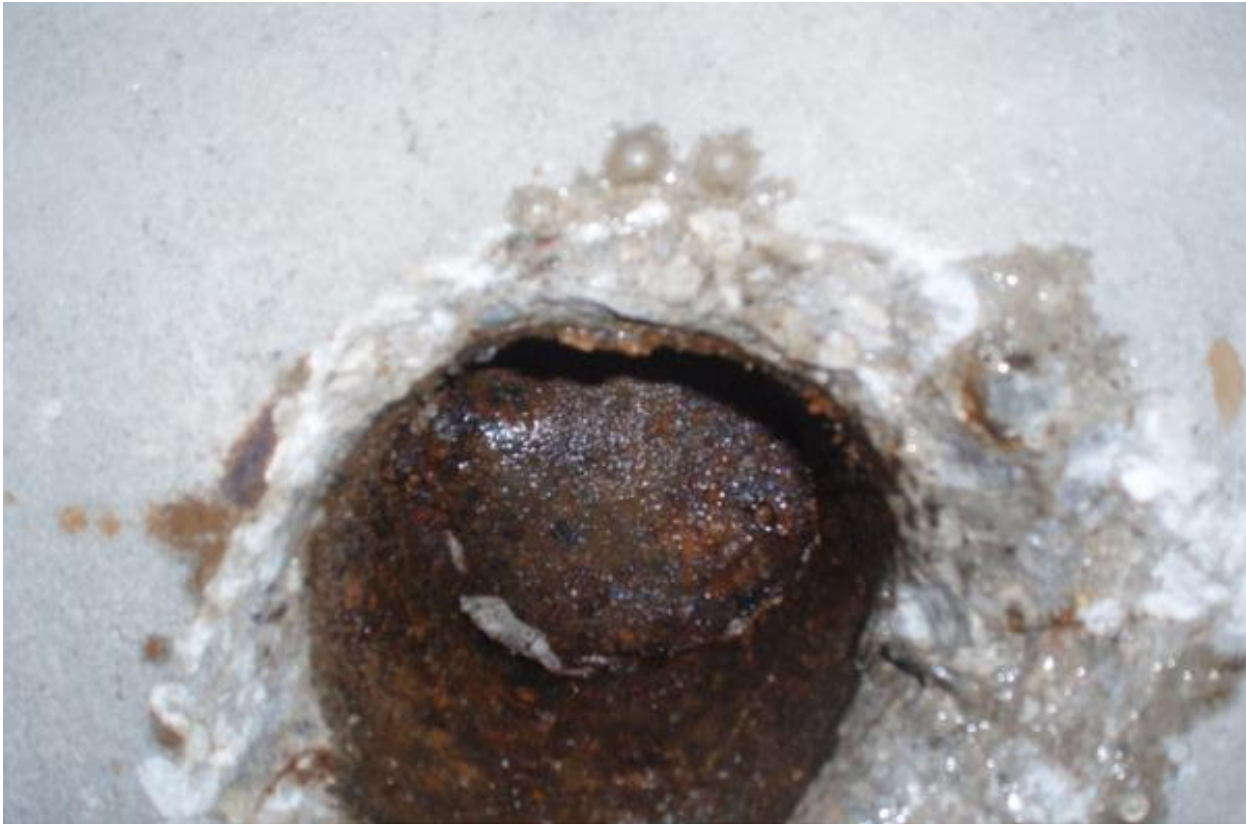
Ceiling slab waterproofing repair
After removing patch mortar, we found an old electrical box
