## Ontario Power Generation (OPG)

A permanent solution to water infiltration

## Active Leak in Manhole CN2000 to coat the interior concrete

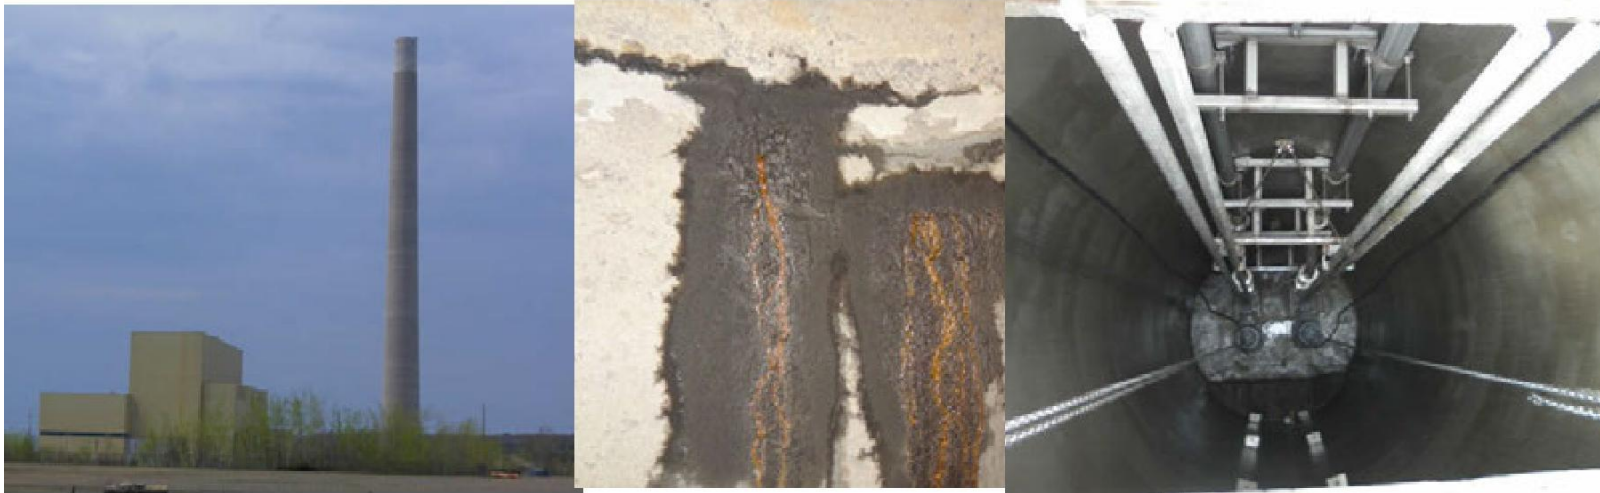
Active leak from groundwater infiltration in 25-foot deep manhole. The water was coming through the joints of the pre-cast concrete and the cracks in the pre-cast pipe.

A coating with resistance to extreme hydrostatic pressure and corrosion; and, an application that can be applied on the inside with confidence to stop the water infiltration.

- Surface preparation completed in two days.
  - Includes scaffolding, chasing the cracks and in this case, water blasting was used

to open the pores and saturate the concrete required for application.

- Application time of two days.
  - CN2000<sup>®</sup> A, B, C and D were applied. CN2000<sup>®</sup> A (Insta-plug) for the active leak areas. Two coats of CN2000<sup>®</sup> B cementitious crystalline on the entire area. One coat of CN2000<sup>®</sup> C&D - a polymer/latex and cement composite applied on the entire area to add flexibility and cure.
  - 24 hour air-dry cure once CN2000 C&D applied.
- OPG can continue the next phase of installing the pipes and releasing the water.
