Phase 2 - Repairing & Waterproofing against extreme hydrostatic pressure CN2000® to coat the interior concrete

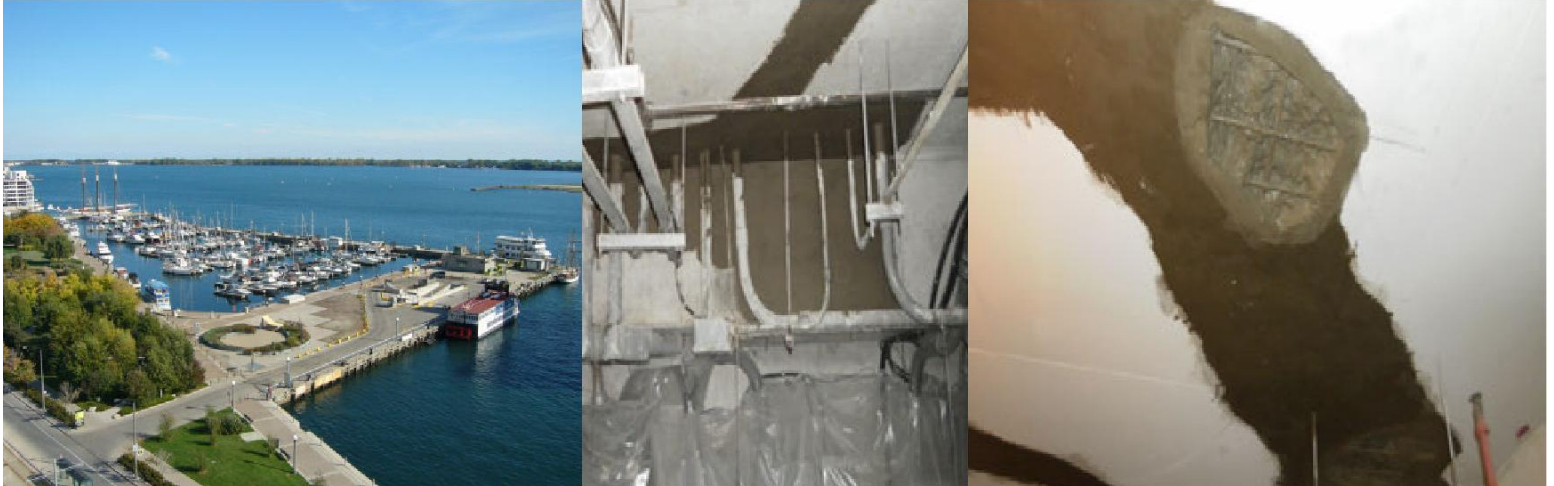
In addition to cracks along the walls and areas of delamination, leaks were evident around the pipe penetrations and the cold joints.

CN2000® was specified by Genivar (now WSP Group). Tested by Queens University and National Research Council of Canada, CN2000® resists extreme hydrostatic pressure and rapid freeze/thaw cycles. The success of the November 2013 application led the general contractor, Macdero, to call Kelso Coatings to complete Phase 2 and Phase 3.

CN2000® was also used to coat the exposed steel rebar to act as an anti-corrosion solution to the steel.
